RM No. E8F29

OPERATING TEMPERATURES OF I-40-5 TURBOJET ENGINE
BURNER LINERS AND THE EFFECT OF TEMPERATURE
VARIATION ON BURNER-LINER SERVICE LIFE

By H. D. Wilsted, Robert T. Duffy
and Ralph E. Grey

WASHINGTON
August 23, 1948

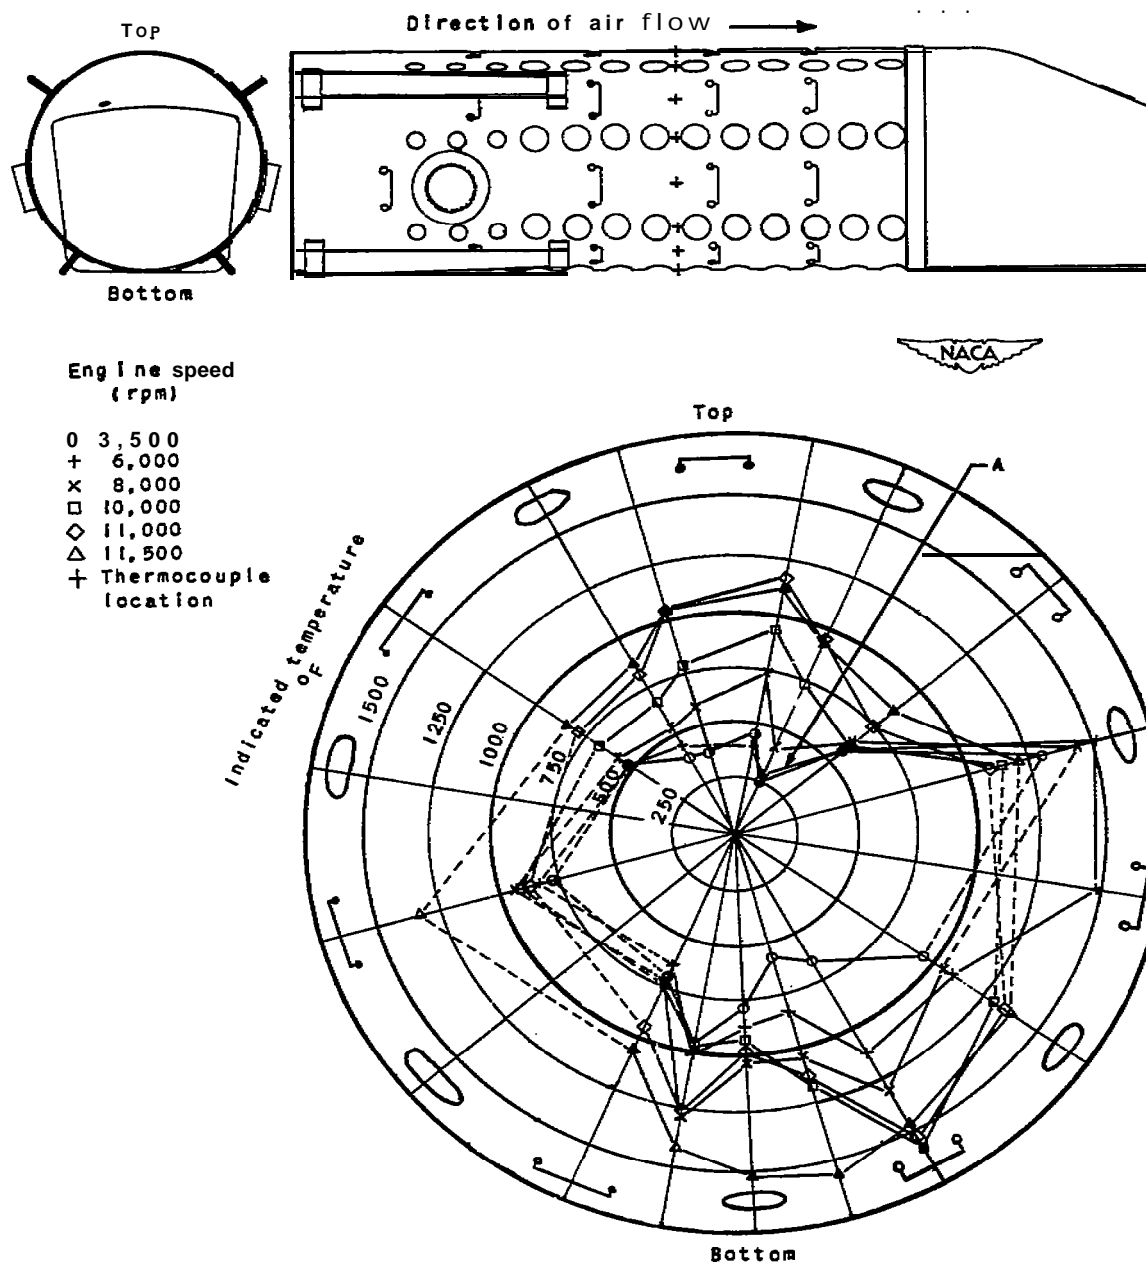
sections containing the louvers and air-intake holes, respectively. An examination of the data shows that the highest indicated burner-liner temperature recorded in these investigations was 1590° F, as shown in figure 9 at an engine speed of 11,500 rpm. This peak temperature occurred in the thermocouple belt $9\frac{1}{2}$ inches from the inlet end of the liner near the critical section.

Temperature gradients as great as 700° F per inch of circumference are shown in figure 9 (point A). The high-temperature gradients from point to point in the burner liner are probably the cause of failure, the principal factor at the present time limiting the service life of the gas-turbine engine. Any process or method that will remove heat from the hot spots or give a more even temperature distribution such as the use of heavier gage metal for the liners to more rapidly conduct heat away from the hot spots or the use of cooling fins to remove heat from the high temperature areas should add materially to the burner-liner service life.

Figure 9. - Circumferential burner-liner temperature distribution near hottest temperature belt on burner liner A at various engine speeds. Average diameter of liner, 5.5 inches. [Dashed lines indicate missing temperature readings as a result of thermocouple failure.]

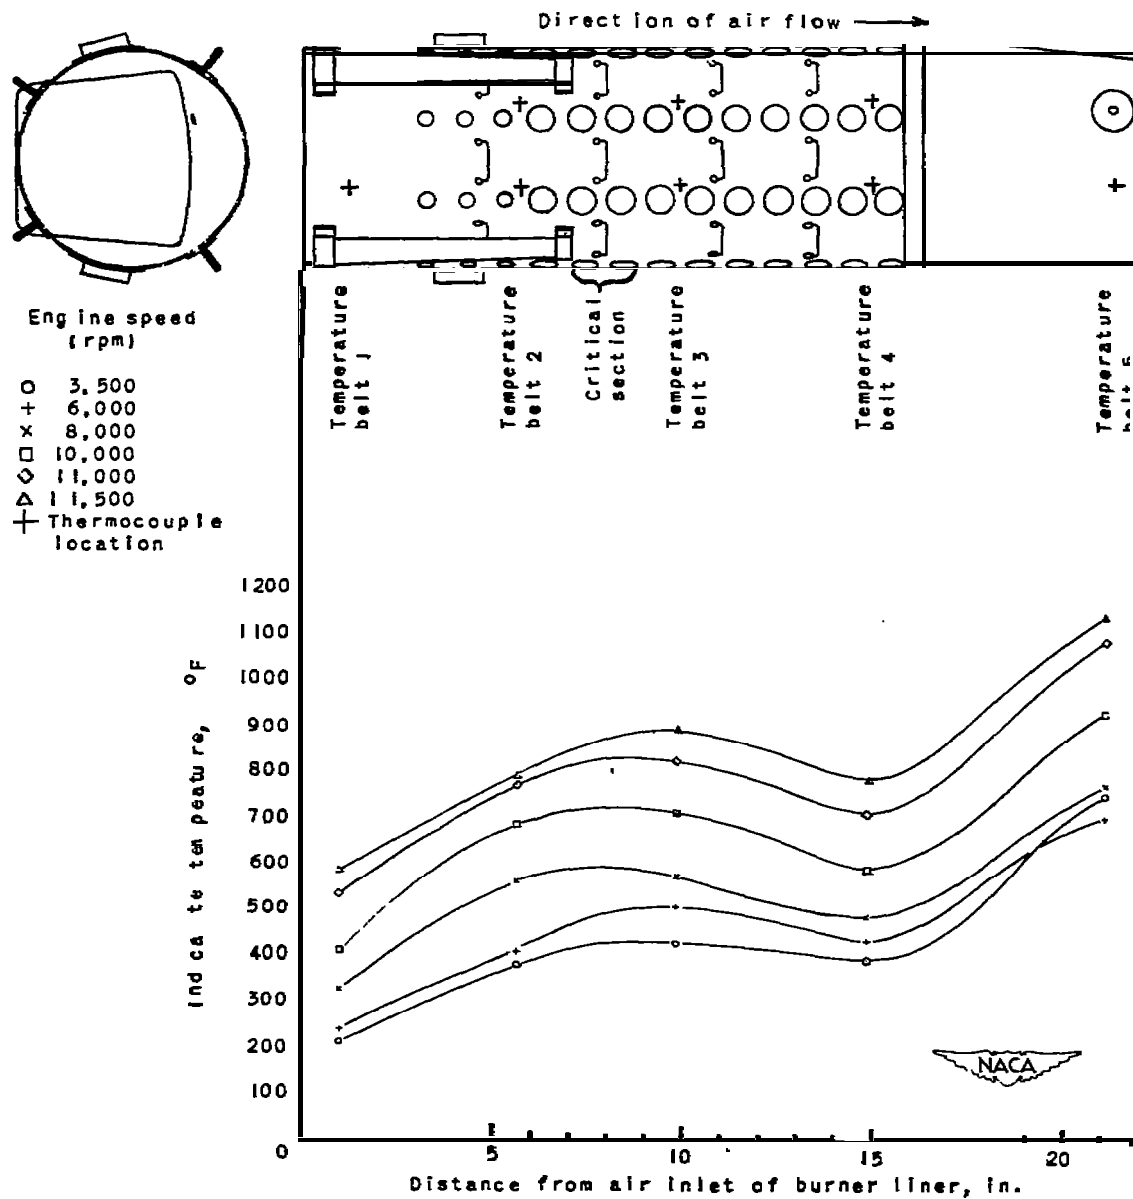
figure 11. The average values show the following trend: a peak in temperature about **one-third** the length downstream on the liner with a greater **peak occurring** at the liner exit. It is in the **region** of the first-mentioned peak **temperature** that liners have failed in IVACA investigations. These failures **occur** in the form of fractures and severe warping **extending** from the louvers to the air-intake holes at a section approximately 8 inches from the inlet end of the liner. This failure belt will hereinafter be referred to as the "critical section." Inspection of service **liners** has also shown failures at other locations between air-intake holes and **louvers** but in **every** case of this **type** there was a **more** serious failure at the **critical** section.

Figure 11. - Temperature variation along length of burner liner B. All points are average of belt temperatures.

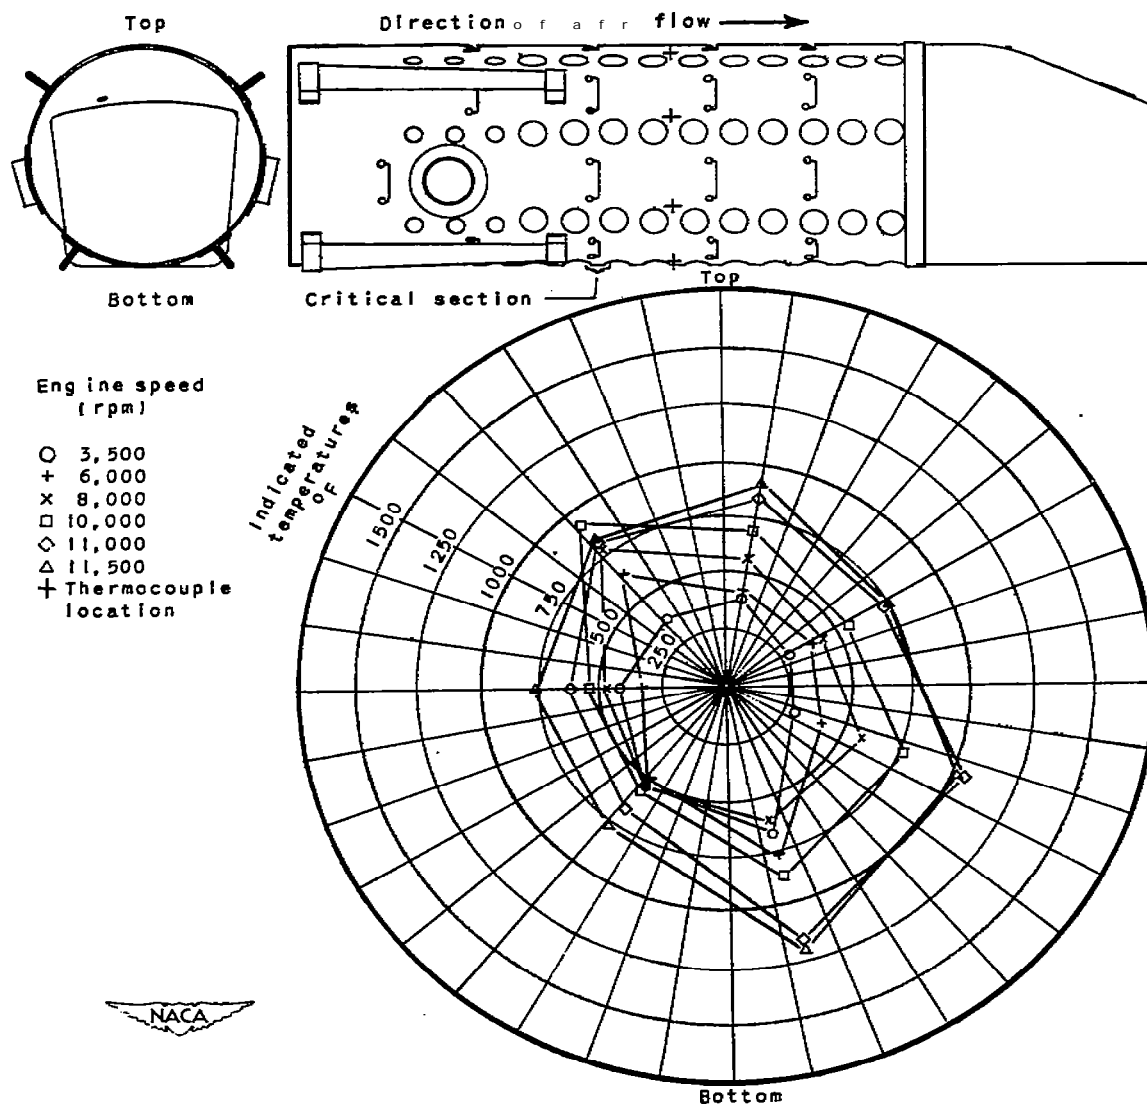
The circumferential temperature **variation nearest** the critical section is presented in figure 13. An appreciable temperature variation occurs with a decidedly high-temperature **region** located at the lowest portion of the burner liner as installed in burner 12. This **peak agrees with that of figure 9**. The high-temperature **region** is behind the right-hand **interconnector** fitting. The axial **temperature distribution** along this section is shown in figure 14 and the **temperature** behind the left-hand interconnector fitting in figure 15. These figures also show the **maldistribution** indicated in figure 13. The peak temperatures behind the right-hand **interconnector** fitting at the higher speeds are of the order of **500° F** greater than the corresponding section behind the left-hand interconnector fitting. Inasmuch as air-flow patterns approaching the burner have **not** yet been obtained, it is not **known** whether this shift is a result of air-flow variations or maldistribution of fuel.

Figure 13. - Circumferential temperature distribution near-critical section of burner liner B at various engine speeds.
